The University of Akron
College of Polymer Science
and Polymer Engineering

Office of Operations - Safety Office

LESSONS LEARNED

August 2019 – NMR LN₂ Fill accident

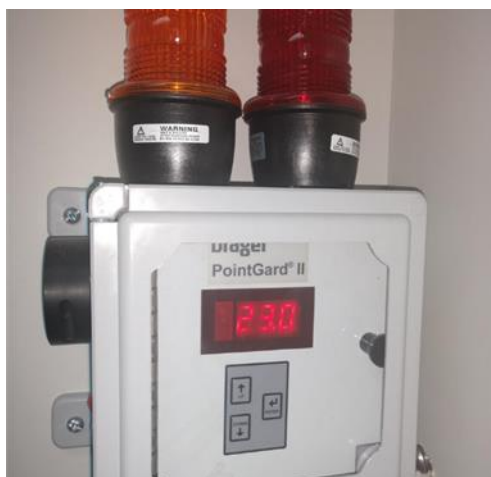
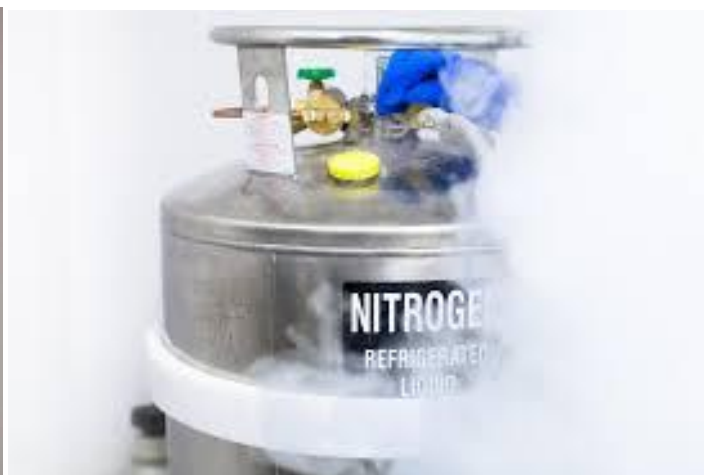
O₂ sensor monitors constant oxygen levels in the area. When O₂ drops below 19.5% the alarm is triggered along with blinking light.
